TOMARK, s.r.o.
Strojnícka 5, 080 01 Prešov

MANDATORY BULLETIN

Number: ZB SD4-04-2013

Name/Subject: Location of the sensing of the static pressure inside the rear of the fuselage

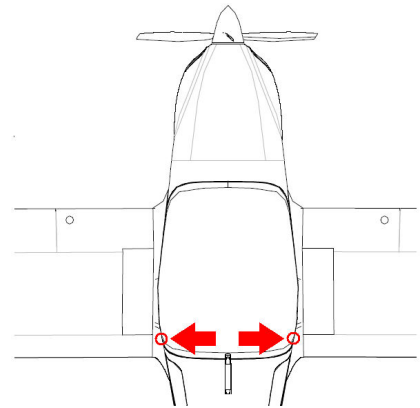
The original static pressure ports are located symmetrically on the sides of the fuselage, below the cockpit windows, as it is shown in the picture on the right.

The static pressure ports have a round shape and are riveted to the insides of the side fuselage skins in the upper part of the baggage area.

The static pressure ports are connected to plastic tubes $\text{Ø}6 \times 1$ mm, leading to the flight instruments located on the instrument panel. The tubes are secured on the static pressure ports by locking clips.

The original static pressure ports, located symmetrically on the sides of the fuselage below the rear window of the cockpit, cause an airspeed indication error in the critical area of stall speeds that is higher than 10 km/h, which may lead to dangerous situations.

With the help of pliers remove the locking clips and disconnect both tubes from the static pressure ports.

NOTE: The tubes may first be cut off, if necessary, close to the ports.
